IEPA - BOW - Peoria

Inspection Report

Pork Hill Farm CAFO Inspection

May 2, 2012

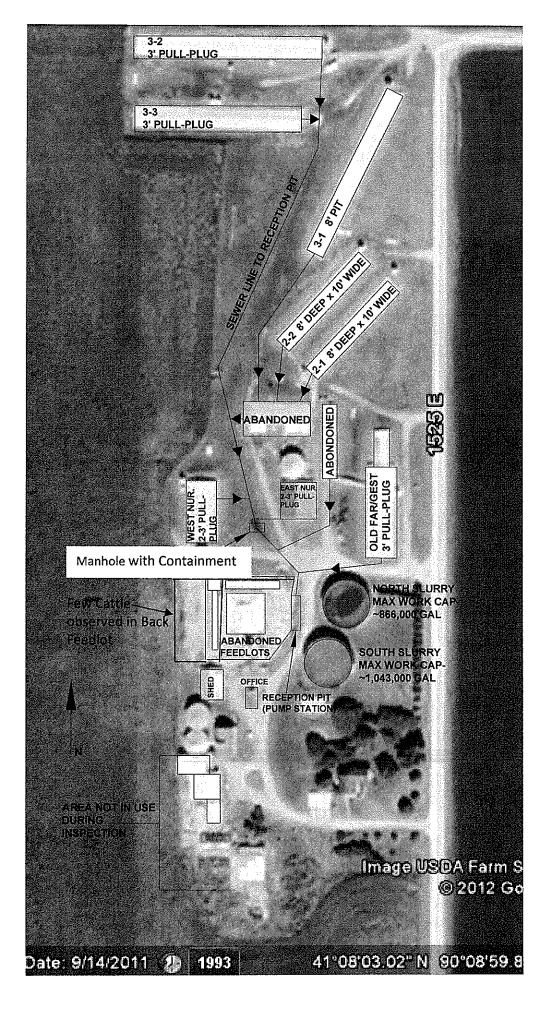
This facility has 8 total confinement buildings on site that are currently being used. During the inspection these buildings were all approximately operating at maximum capacity. Below is a summary of the buildings with estimated dimensions and capacities. Please see Figure 2 for locations on site.

Below are further details of the manure collection system. For a visual of the system please see Figure 2.

Figure 2. Plan View From Google Earth of Pork Hill Farm located near Altona in Knox County on May 2, 2012.
